**I-90 MP 16.21 Unnamed Tributary to Tibbetts Creek
(WDFW ID: 991182)**

Preliminary Hydraulic Design Report

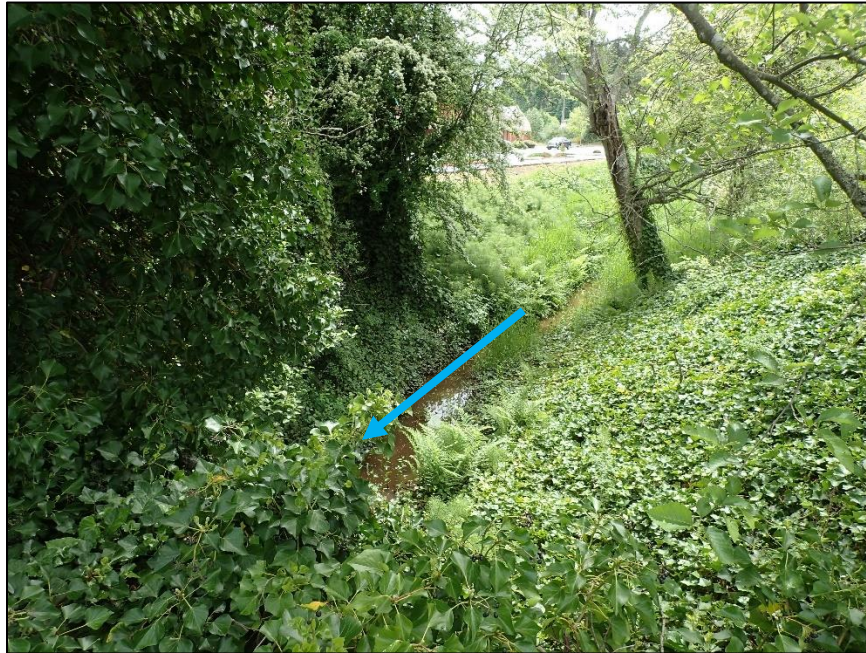
There is varied potential for large wood recruitment within the immediate vicinity upstream and downstream of I-90. The existing riparian corridor between WDFW Culvert ID: 920193 and the I-90 culvert inlet contains mostly invasive English ivy and a few mature cottonwoods (Figure 39). There were a few small pieces of wood in the stream (DBH one foot or less) influencing channel hydraulics by forming small log jams and scour pools (Figure 22). The mature trees provide ample shading in this short reach. There are fewer trees upstream of WDFW Culvert ID: 920193. Both banks have been colonized by

Figure 39: Riparian conditions upstream of the I-90 crossing between Station 14+50 and 14+00 (arrow indicates flow direction)

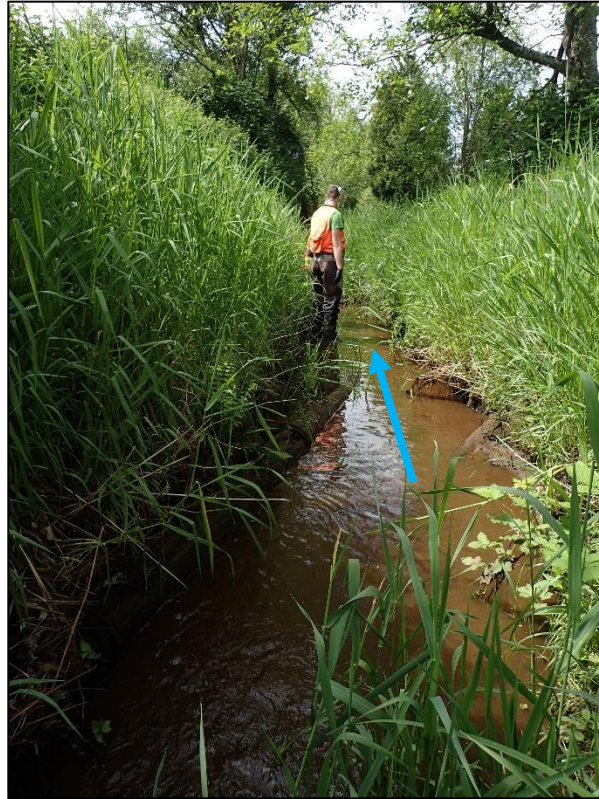
Immediately downstream of I-90, the dominant riparian vegetation on the channel bench is reed canary grass (Figure 40). There is limited shade and large wood recruitment potential in this reach. The riparian corridor transitions from mostly grass to increasing mature tree canopy starting 200 feet downstream of the I-90 culvert outlet. Downstream of this transition, the stream is shaded by mostly alder and cottonwood trees on the banks and channel bench, supplying natural LWM to the channel. The reference reach contains a mix of trees, grass, and shrubs including some Himalayan blackberry and fern.

Figure 40: Riparian conditions downstream of I-90 showing the transition from reed canary grass to more dense woody trees further downstream (blue arrow indicates flow direction) (Sta. 07+50)

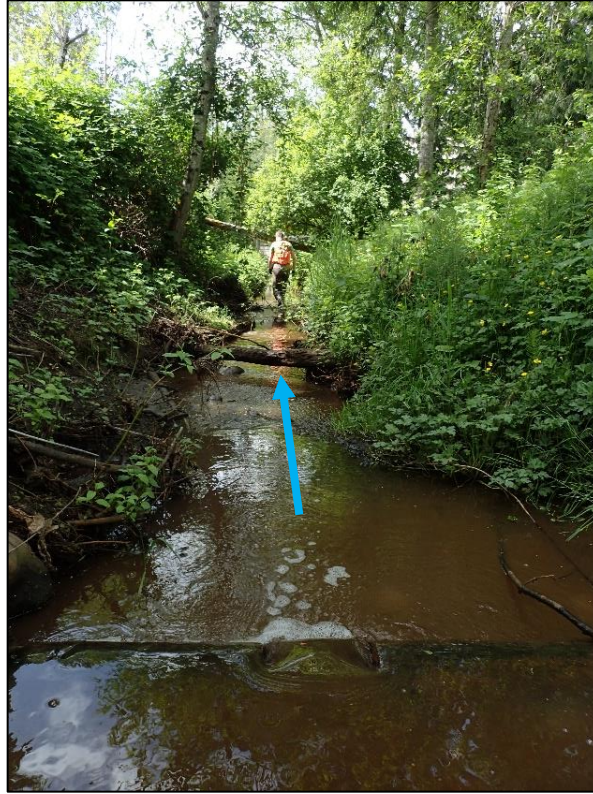
Instances of in-channel LWM increase downstream of I-90 as a result of past restoration projects in the reach. Engineered LWM was observed anchored into channel banks, in toe structures, and spanning the width of the channel to create notched log weir structures. The average DBH of the engineered wood is 1.5 feet and only one piece of large wood was used to create each wood feature in this restored zone. To target Kokanee habitat rehabilitation, the project avoided multi-piece racked designs that create deeper pools that attract predatory smallmouth bass (Monahan, personal comm. 2020). Greater channel complexity was observed downstream in the partially restored section of the stream than upstream of the crossing, especially in the more dense canopy area (Figure 41). Sand and gravel accumulate upstream of the log weirs adding hydraulic roughness to the channel in the form of riffle bed structures. Downstream pools have formed ranging from 1 to 1.5 feet in tail-out depth. The LWM is therefore acting as grade control downstream of I-90.

Figure 41: View of riparian corridor in the reference reach showing notched log weir structures and natural wood recruitment (blue arrow indicates flow direction) (Sta. 03+16)

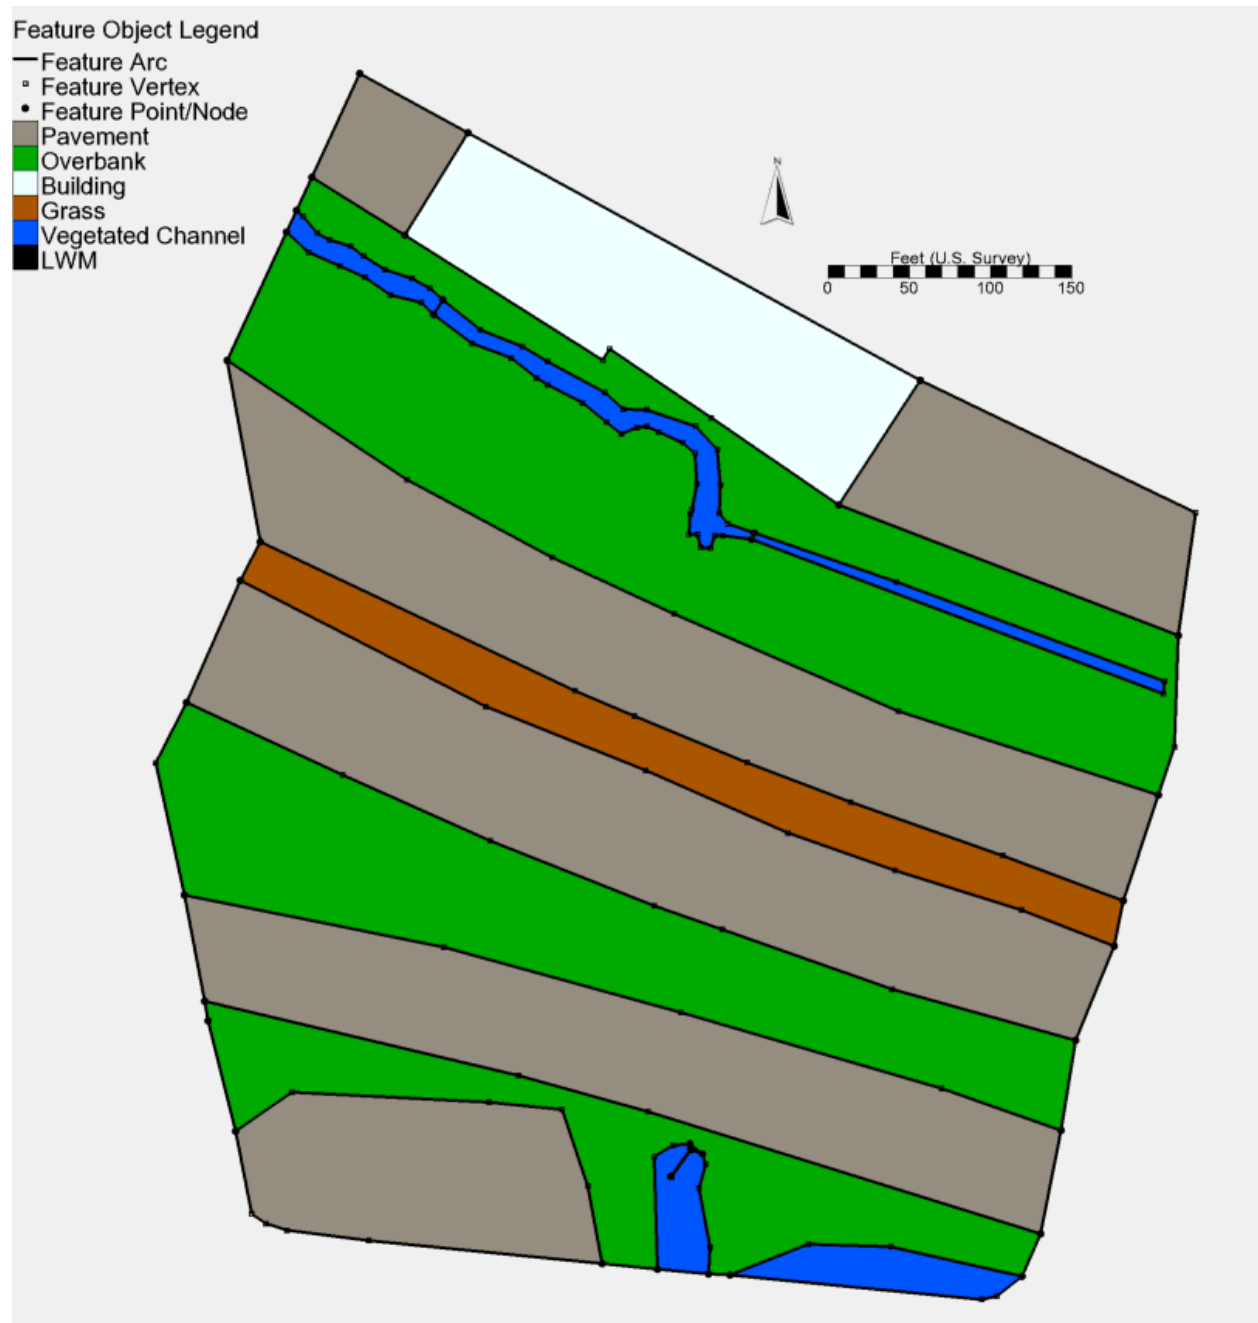
Figure 45: Spatial distribution of roughness values in the existing condition SRH-2D model

Land Cover Type	Manning's n
Pavement	0.013
Grass	0.03
Building	0.20
Existing Overbank	0.065
Existing Channel	0.035
Proposed Channel – No LWM	0.035
Proposed Channel – With LWM	0.055

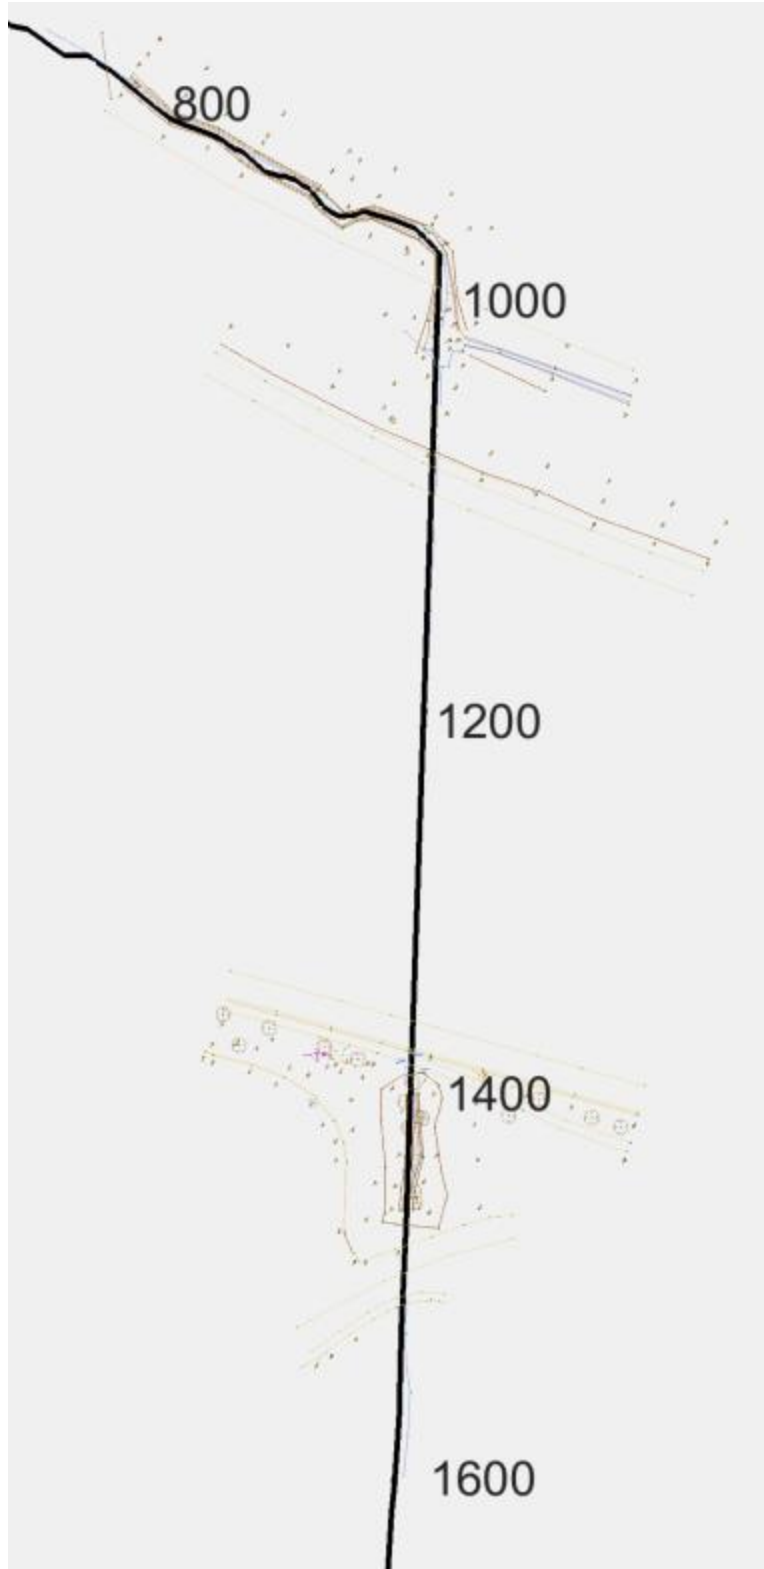
Figure 51: Longitudinal profile stationing for existing and proposed conditions

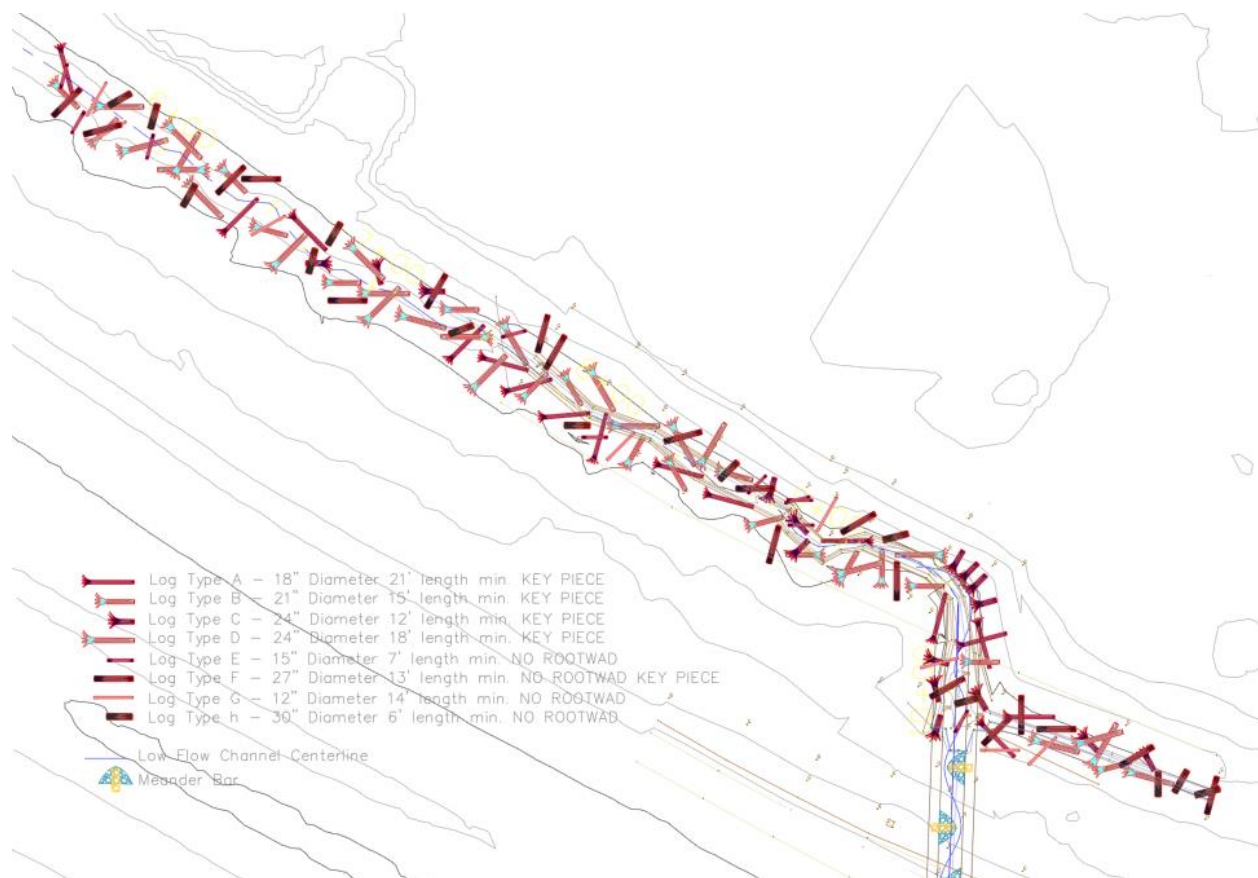
Figure 63: Conceptual layout of habitat complexity (downstream end)

Coarse bands were not determined to be beneficial for aquatic habitat in this reach. Low flow meander bars are proposed on the inside of low flow meanders within the structure. They will consist of well-graded stream bed sediment that is one to two times D_{100} (the largest particle found in the bed). Fine bands consisting of Streambed Fine Sediment, a natural or manufactured sand, meeting the grading requirements (WSDOT, 2019) shall be placed around meander bars to prevent piping. The intent of the meander bars is not to encourage planform meandering but to prevent entrainment and plane-bed formation, as well as to provide velocity breaks for aquatic species. Low flow meander bars will be installed following a modified version of bendway weirs/stream barbs from FHWA (2009). The angle of projection between the bar axis and upstream bankline is 45 degrees. The length of the bars will be six feet, and project just beyond the thalweg, and three additional feet will be keyed into the overbank at a depth equal to D_{100} . The height of the bar will transition from the height of the overbank at the bank to 0.6 feet high at the thalweg at a slope of between five to eight percent. The top width of the bars is proposed to be three feet at the intersection with the bank, transitioning down to one foot near the thalweg, allowing two to three boulders at the D_{100} size to be utilized. The meander bar will consist of a core consisting of the one- to two-times the D_{100} ; the streambed mix will be used to smoothly transition

to and from the core dimensions back to the typical stream section, over the course of the entire meander. The spacing for the meander bars was determined based on the meander belt width (USGS, 1986). Because the channel is moderately confined, typical meander function may not be applicable. The meander bar spacing based on meander belt width was also checked against meander wavelength observed in the reference reach and resulted in a wavelength of 45 feet.

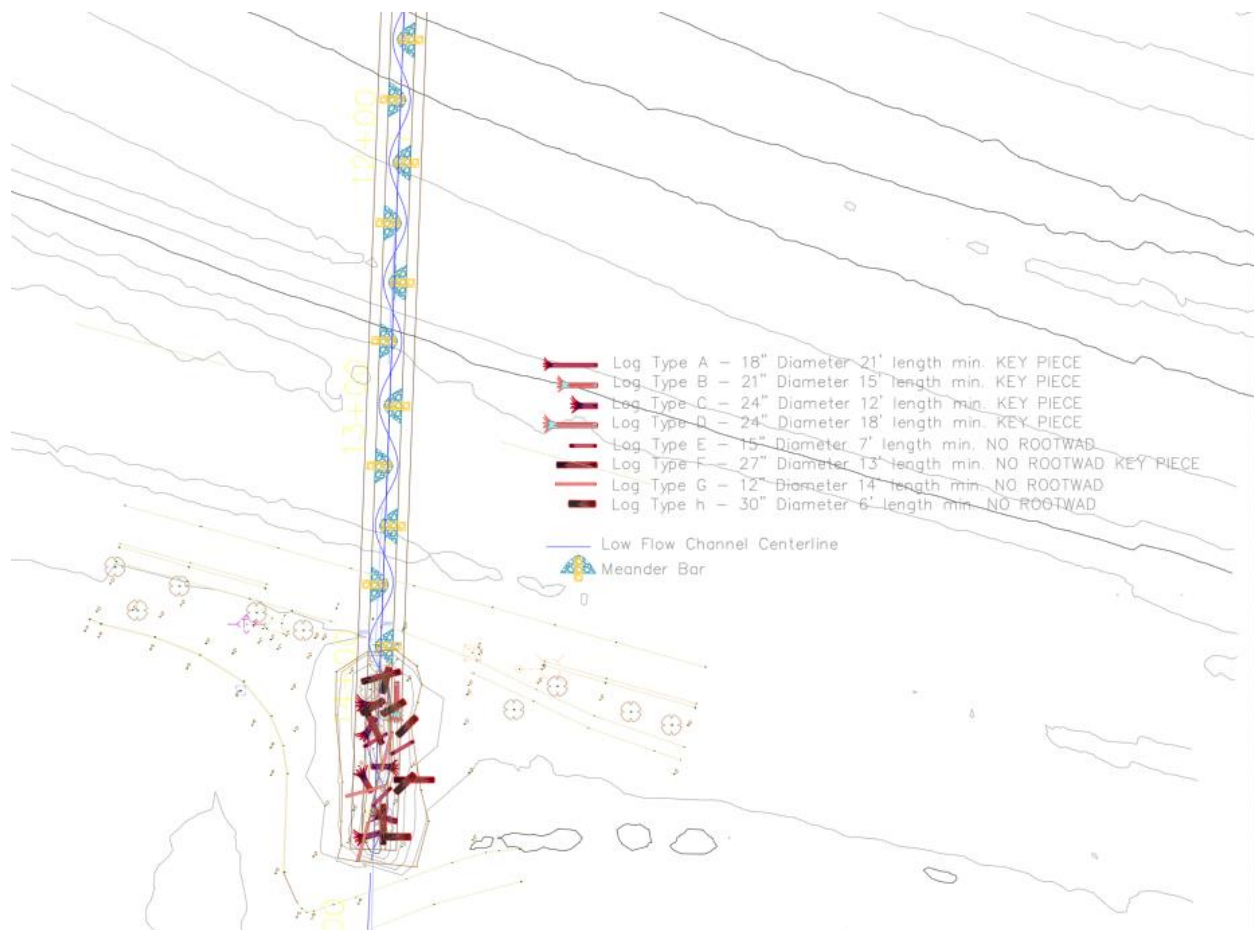
Figure 64: Conceptual layout of habitat complexity (upstream end)

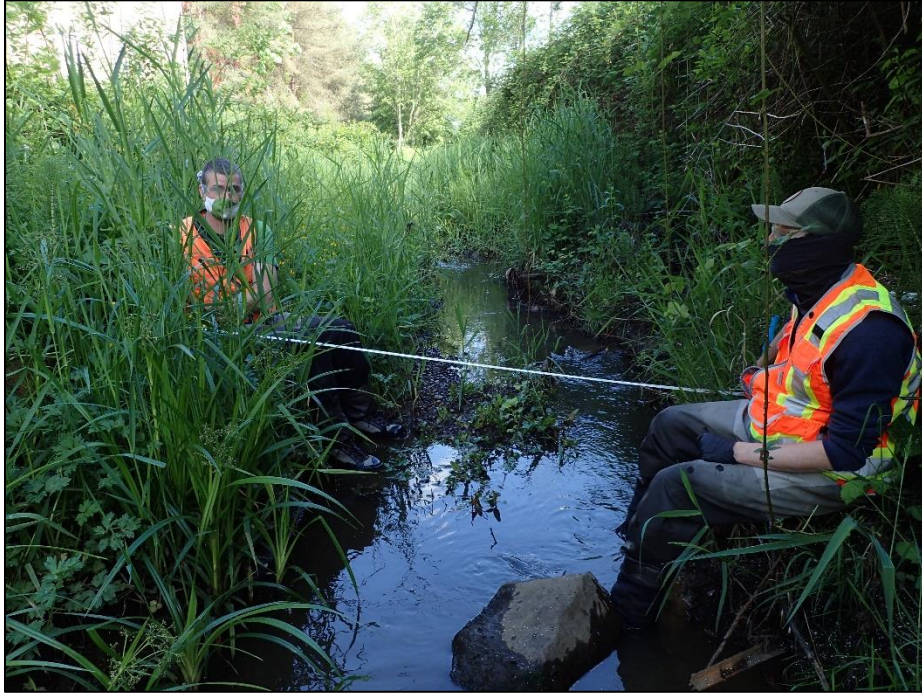
Figure B-66 BFW 1

Name	Organization	Role	Annie Dufficy	Northwest Hydraulic Consultants	Geomorphologist	Tyler Rockhill	Northwest Hydraulic Consultants	Hydraulic Engineer	Alex Anderson	Northwest Hydraulic Consultants	Hydraulic Engineer
Name	Organization	Role													
Annie Dufficy	Northwest Hydraulic Consultants	Geomorphologist													
Tyler Rockhill	Northwest Hydraulic Consultants	Hydraulic Engineer													
Alex Anderson	Northwest Hydraulic Consultants	Hydraulic Engineer													
Bankfull Width:															
<p><i>*Blue flagging was labeled and tied to vegetation on the channel banks for all BFW measurements</i></p> <p><i>BFW 1 was measured behind Big Lots (beige brick part of the building) in a channel bend glide over a small boulder in the channel (Figure B-66). Measured BFW was 8 feet. This location is 200 feet downstream of the I-90 culvert.</i></p>

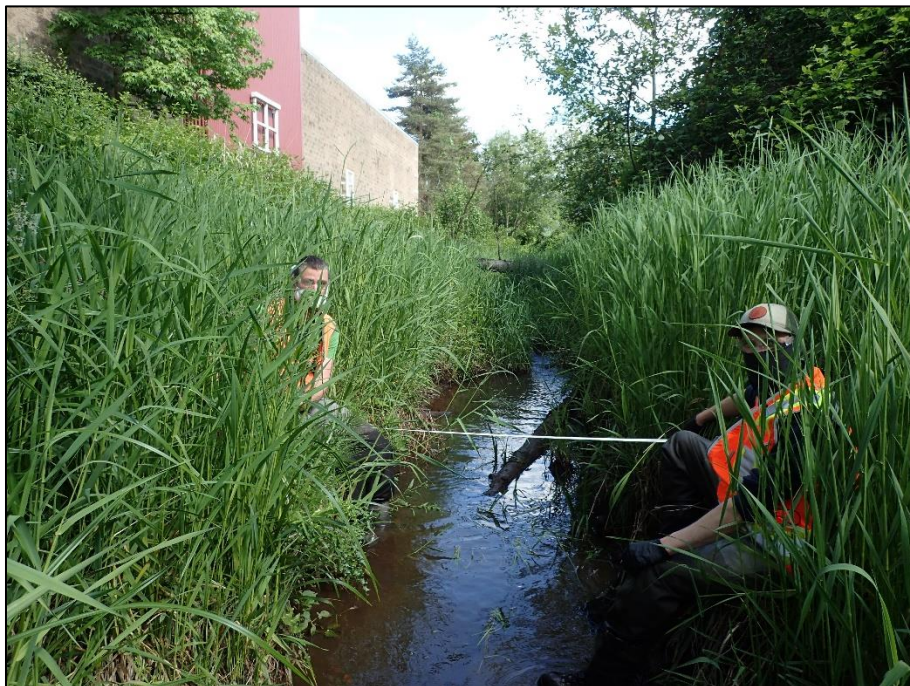
Figure B-67 BFW 2

BFW 2 was measured at the southwestern corner of the Big Lots building in a long glide with reed canary grass on both banks (Figure B-67). Measured BFW was 9 feet. This location is 300 feet downstream of I-90.

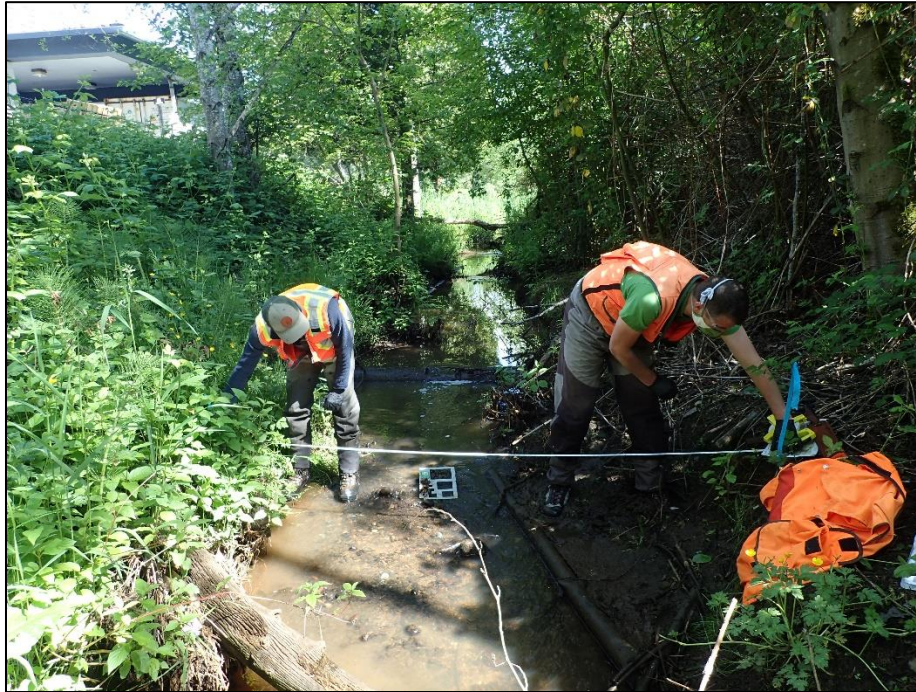
Figure B-68 BFW 3

BFW 3 was measured behind PetSmart about 40 feet downstream of the Girken Ski shop (you can see the awning of the ski shop in the photo below (Figure B-68). This was measured in the reference reach in a wood-forced riffle downstream of a notched log weir. Measured BFW was 9.5 feet.

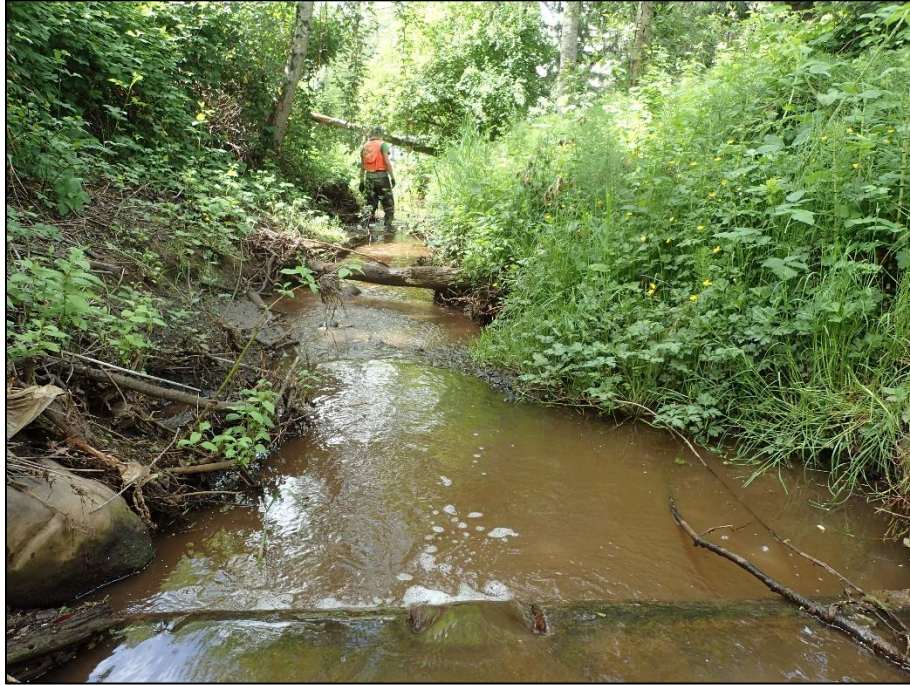
The reference reach includes the partially restored stream segment downstream of the I-90 crossing starting about 200 feet downstream of the crossing and extending downstream just before the steep riffle reach 150 feet upstream of the city culvert (WDFW Culvert ID 920196). This is also commonly known as the 12th Avenue restored reach of Pickering Creek by the Lake Sammamish Kokanee Working Group. The stream maintains an average slope of about 0.45% through the reach, which is fairly consistent with the slopes observed throughout the crossing vicinity. Large wood additions to the stream include log weirs and logs anchored to the stream banks, DBH of about 1 to 2 feet. This wood has added hydraulic complexity by encouraging upstream sediment deposition of coarse sands and gravels and downstream scour pools, resulting in wood-forced riffle-pool sequences. The channel has established some sinuosity in this restored reach. NHC measured meander sinuosity of 1.07, defined as the ratio of the channel length to the corridor length. Bankfull width varies from 8 to 10 feet in the reach. Starting 200 feet downstream of the I-90 crossing the reach transitions from grass-dominated banks to a dense woody canopy. In this segment, channel banks are locally shallower.

Figure B-69 View looking downstream of the reference reach at a notched-weir-forced riffle

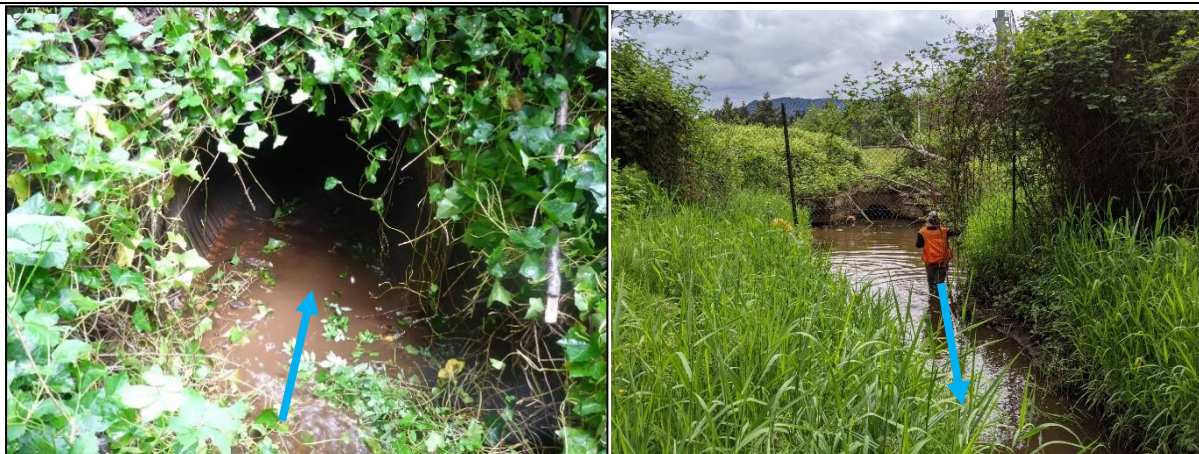
The northern Unnamed Tributary to Tibbetts Creek in the vicinity of the I-90 MP 16.21 crossing is a channelized stream. Under existing conditions, the tributary is constrained laterally within a narrow urban corridor. Downstream of the crossing the channel is entrenched 2 to 3 feet below a vegetated bench. The beds and banks are composed of mostly clay and organic material, but previous large wood restoration work downstream of the crossing has introduced channel complexity in the form of riffle-pool sequences and alluvial bed deposits in the wood-forced riffles. At the time of the survey, the culvert inlet was mostly clear of sediment and debris, apart from pervasive ivy growth in the area (Figure B-70). The wetted channel width was about 4 feet upstream of the culvert inlet and no backwater was observed. Conditions change downstream as NHC observed a deep scour pool at the culvert outlet with existing water levels filling the 15-foot wide wingwall area up to about half of the culvert's height.

Figure B-70 Existing conditions at the I-90 culvert inlet (left) and outlet (right) (blue arrows show flow direction)

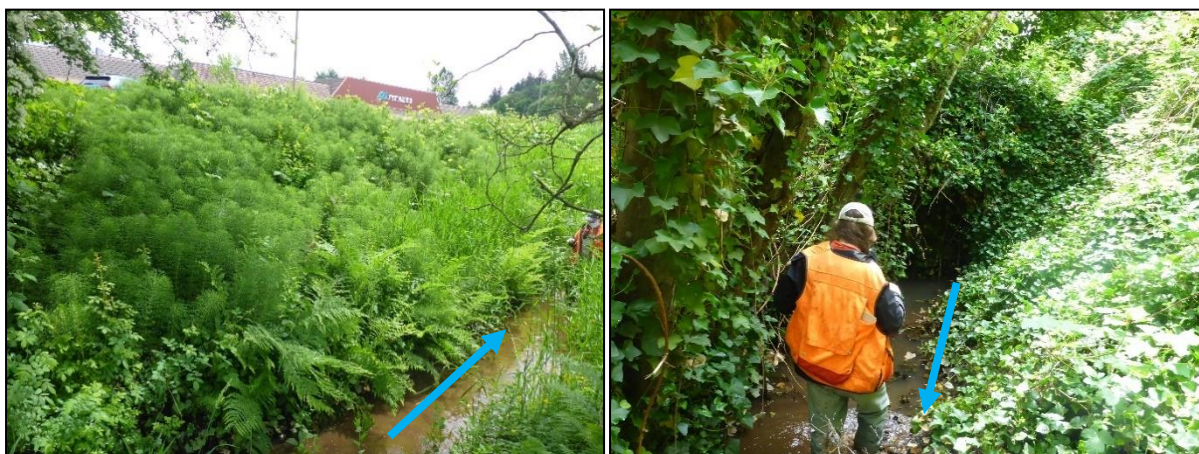
NHC walked 400 feet upstream of the I-90 MP 16.21 culvert observing stream and riparian conditions across the two culvert crossings immediately upstream (Figure B-71). The channel is mostly straight flowing through a narrow 60-ft corridor bound on either side by concrete parking lots of the commercial shopping area. The channel is only about 5-ft wide upstream, bound by steep overbank slopes densely vegetated with shrubs. Closer to the I-90 culvert inlet the riparian area is occupied by English ivy and some trees that have introduced wood into the stream. Although constrained laterally, the narrow channel has established some minor sinuosity and exhibits glide morphology. Wood-forced riffles are present in the reach between WDFW Culvert ID 920194 and the I-90 culvert inlet. NHC conducted a pebble count on this bed in order to characterize the approximate bedload composition available to the reach downstream of I-90.

Figure B-71 Conditions upstream of the WDFW Culvert ID 920194 (left) and upstream the I-90 project culvert (right) (blue arrows show flow direction)

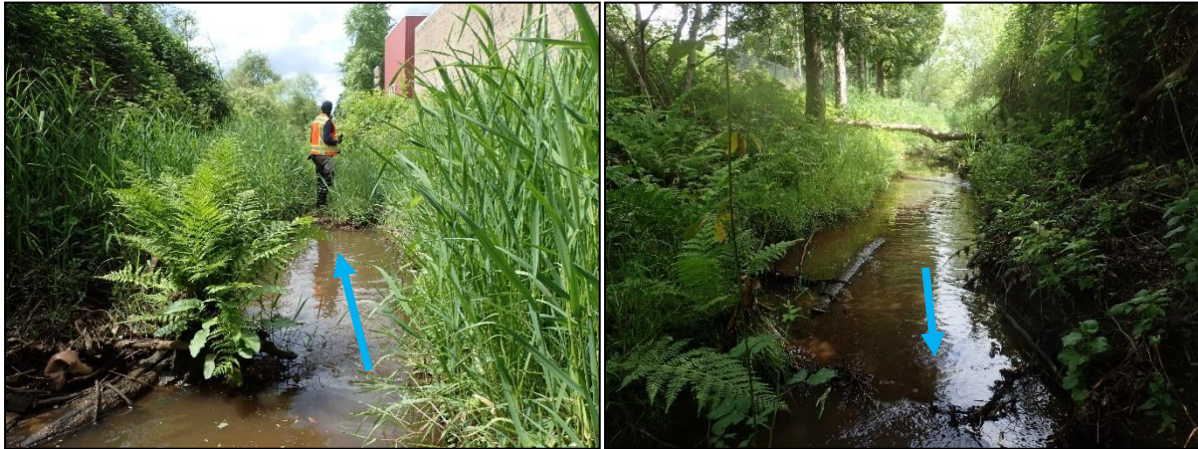
Channel shape and morphology change downstream of I-90 (Figure B-72). The stream is restricted within the 100-ft wide corridor bound between I-90 eastbound on the left bank and commercial property (Big Lots, Girken Ski Shop, and PetSmart) on the right bank. The channel widens to the full width of the wingwalls at the culvert outlet and then narrows to 4 to 8 feet for the first 100 feet downstream. Below this BFW widens with the addition of LWM to a width of 8 to 10 feet. The channel is entrenched about 2 to 3 feet below a vegetated channel bench that accommodates higher flows. The bed and banks are composed of cohesive clay but coarse gravel beds were observed in glide and riffle reaches influenced by LWM. Large wood has been added to the stream, both anchored along banks, and functioning as log weirs further downstream. All notable riffle-pool sequences are wood-

forced. The riparian area within the first 200 feet of the culvert outlet is restricted to mostly reed canary grass and blackberry, but transitions into a dense canopy of mature trees downstream, adding natural wood to the channel in addition to the engineered logs.

Figure B-72 Conditions 100 feet downstream of I-90 behind Big Lots (left) and a view of the partially restored channel located behind PetSmart 400 feet downstream of I-90 (right) (blue arrows show flow direction)

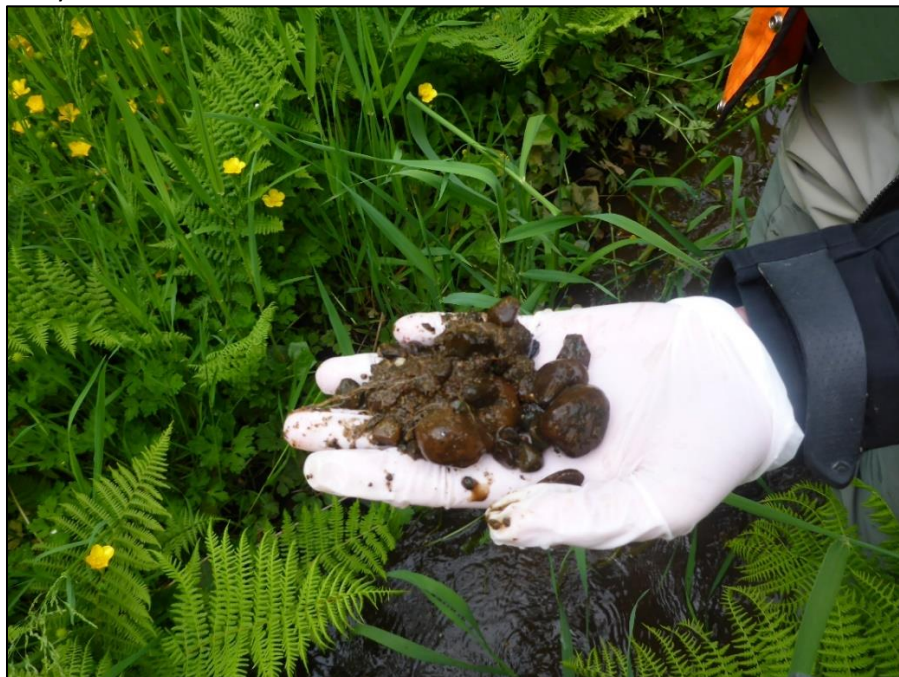
The first pebble count was measured in a wood-forced riffle-glide 30 feet upstream of the I-90 culvert inlet (). This is just downstream of the largest LWM jam upstream of I-90. Channel widths in this reach are only about 5 feet.

Figure B-8 Pebble Count 1 taken 30 feet upstream of I-90 culvert inlet in riffle bed

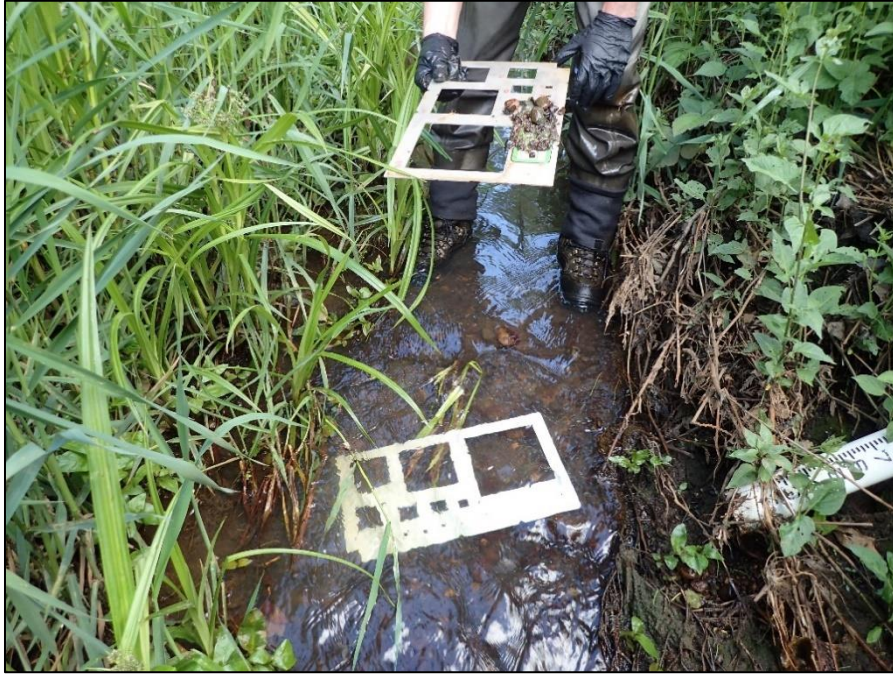
The second pebble count was measured in a very narrow riffle-glide about 80 feet downstream of the culvert outlet where channel width is only 3 feet wide. This reach is located behind the southeastern corner of the Big Lots building. The gravel was imbricated and armored.

Figure B-9 Pebble Count 2 taken in narrow riffle segment

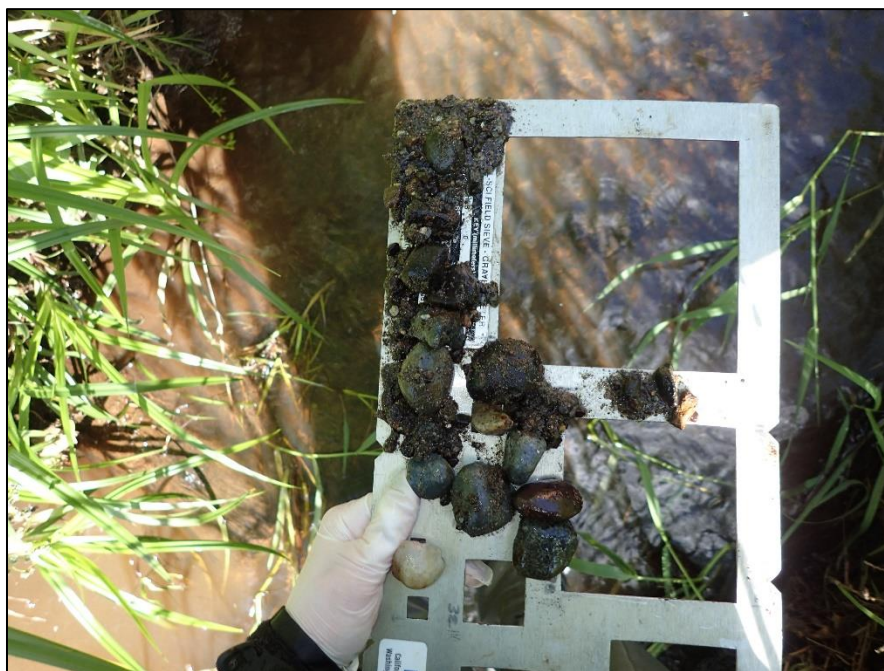
Figure B-10 Pebble Count 3

The third pebble count was conducted in a wood-forced riffle influenced by natural and engineered wood in the reference reach. The bed was armored, protecting fine gravel and sand underneath, which overly the massive clay substrate that bounds the entire downstream reach. This was measured about 10 feet downstream of Pebble Count 2 at the southwestern corner of the Big Lots building.

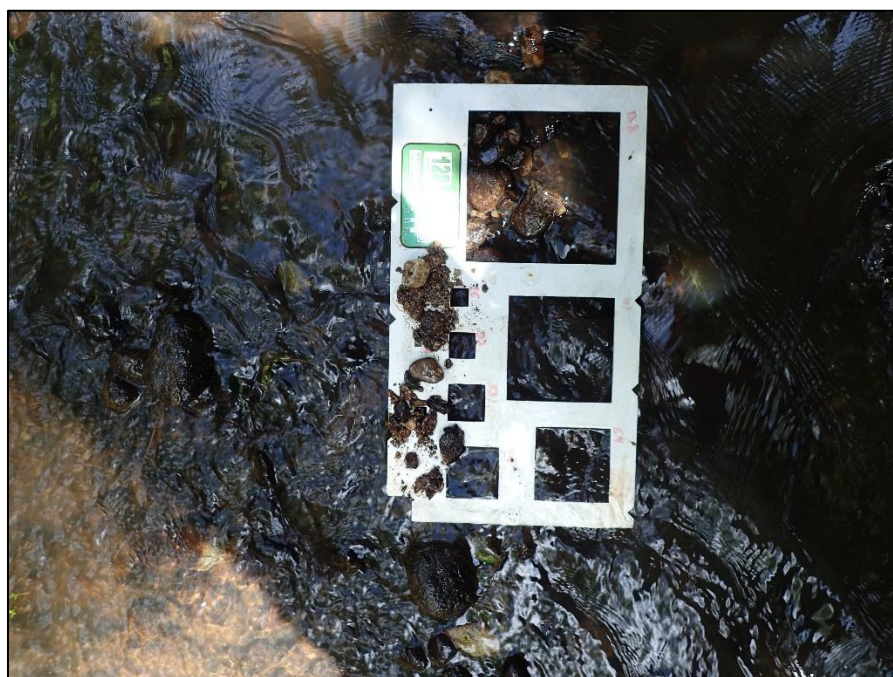
Figure B-11 Pebble Count 4

The fourth and final pebble count was conducted downstream of a notched-log-weir-forced riffle. The deposit was imbricated and armored, protecting the same fine substrate as observed in Pebble Count 3. This was taken at the same location as BFW 3.

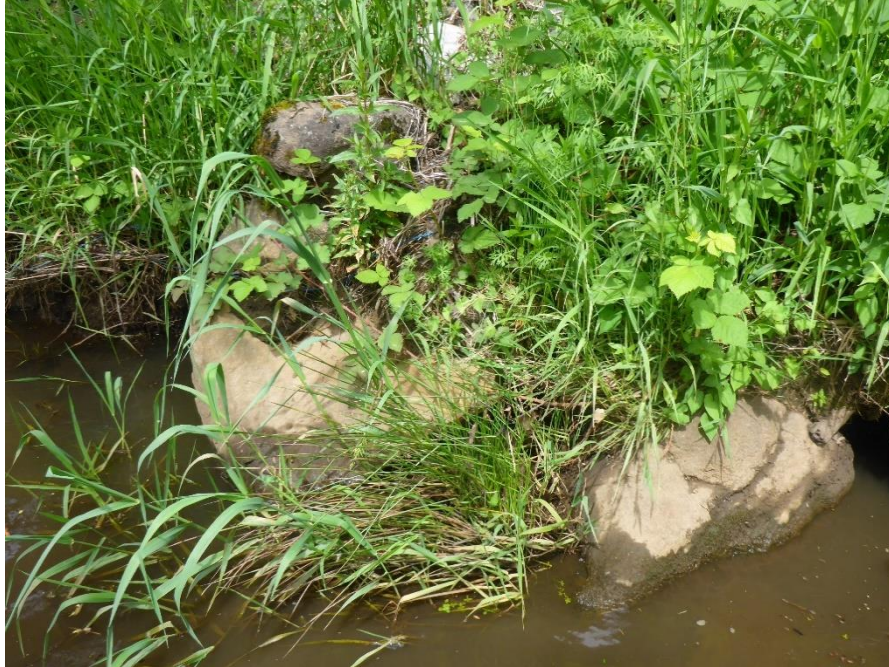
A few boulders were observed in the field. These are not naturally occurring and likely placed as bank protection. These were observed about 80 feet downstream of the I-90 culvert outlet on the right bank and on the bed at the location of BFW 2.

Figure B-12 Large boulder observed on right bank approximately 80 feet downstream of I-90 culvert outlet

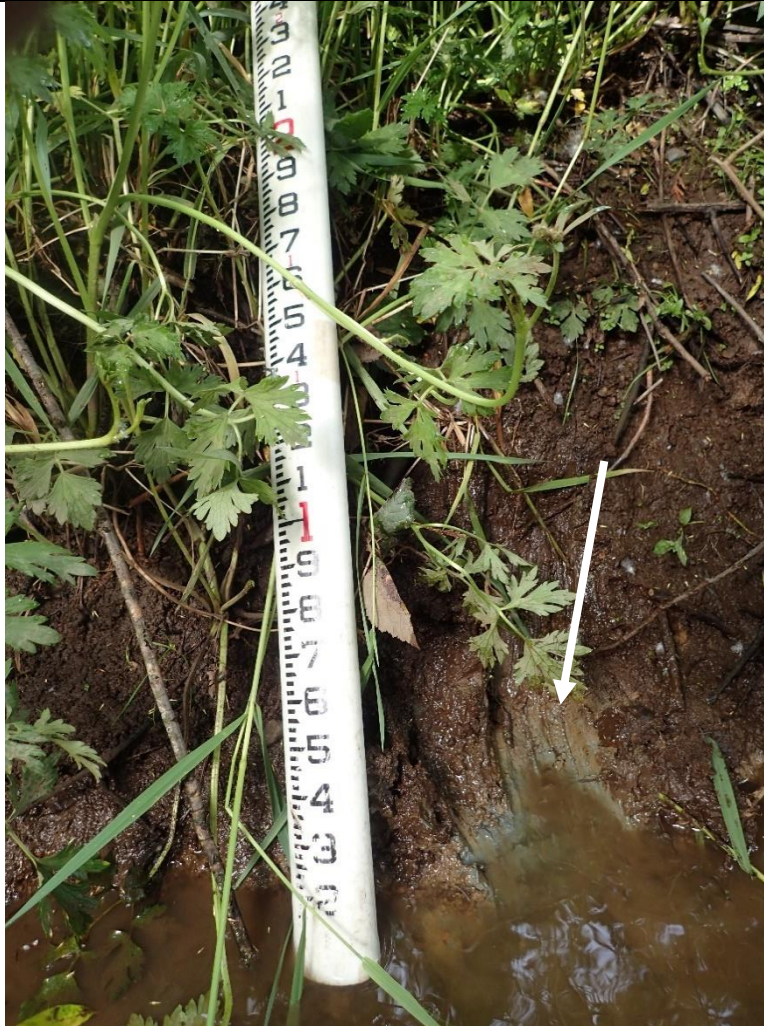
Figure B-13 Clay exposed on the banks (top) and bed below the I-90 crossing (bottom) (white arrow points to clay)

It is believed that a lot of the sediment observed downstream was placed in the 12th Ave restoration project, completed over the past ten years. Plans to this project were not made available to NHC for official review. Regardless, this stream does not have an abundant sediment supply, as observed by it's mostly clay or fine-grained bed.
